FINAL REPORT
CDRL A030
WETLANDS MITIGATION FOR LANDFILL 3
AT
KESLER AFB, MISSISSIPPI

**FINAL REPORT
CDRL A030
WETLANDS MITIGATION FOR LANDFILL 3
AT
KEESLER AFB, MISSISSIPPI**

**Contract No. F41624-94-D-8106
Delivery Order No. 0089**

**IT Corporation Project No. 920568
Revision No. 0**

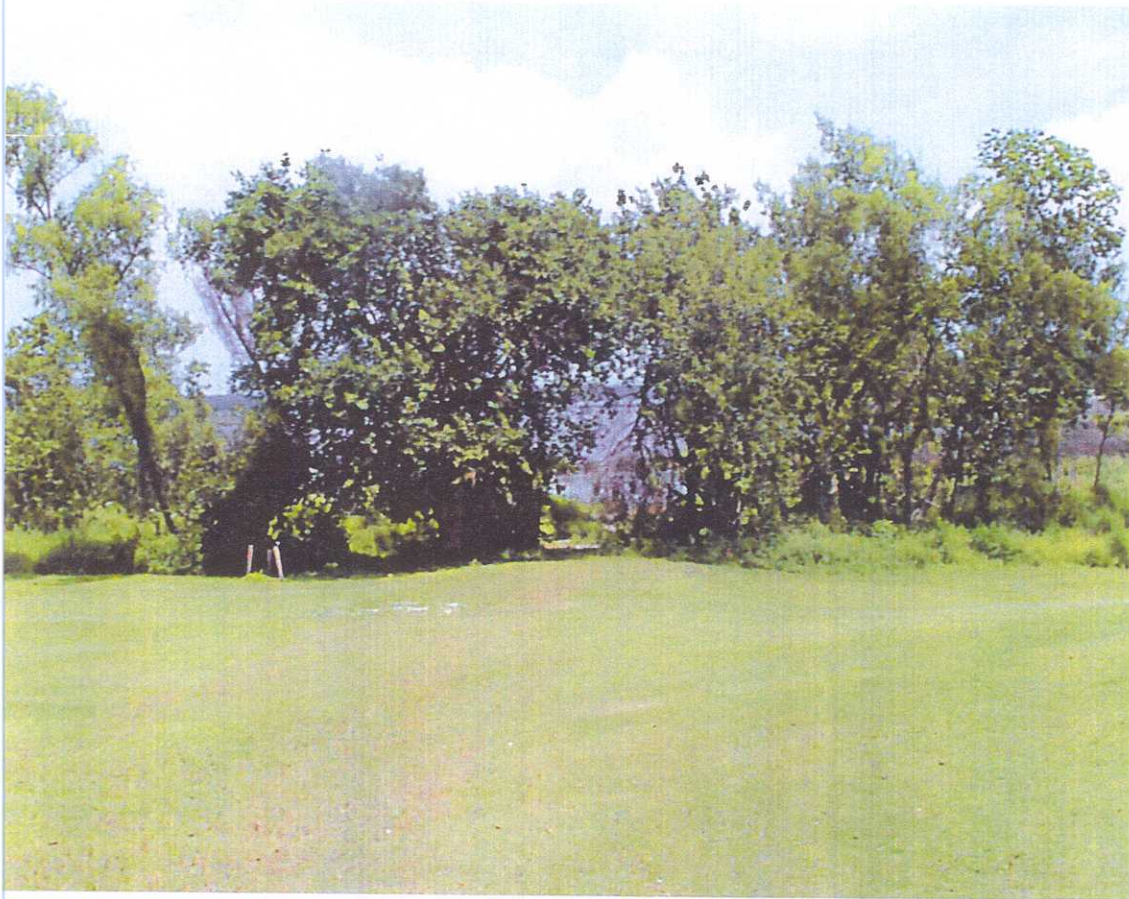
Mitigation area looking toward the Back Bay

Excavation of the archery range to create wetlands began on December 28, 1998. IT encountered large quantities of concrete and asphalt rubble that had been used as fill material. Concrete, asphalt and fill material were hauled to LF3 and used as general fill. December 29, 1998 IT continued excavation of the archery range and encountered seventeen (17) creosote pilings that had been driven for a foundation. IT was unable to remove the pilings with the equipment on site and with concurrence from the Team Chief and Base Point of Contact the pilings were left in place and the fill material around them was excavated. December 30, 1998 IT continued excavation of the archery range and encountered two large triangular shaped pieces of concrete approximately eighteen (18) inches thick. The concrete was unable to be removed with the equipment on site. With concurrence from the Team Chief and Base Point of Contact the concrete was left in place and the fill material around the pieces was removed. December 31, 1998 IT completed the excavation of the fill that had been identified to bring the archery range to the elevation of the surrounding wetlands. Excavated material from the archery range was hauled to LF3 and disposed of as general fill.

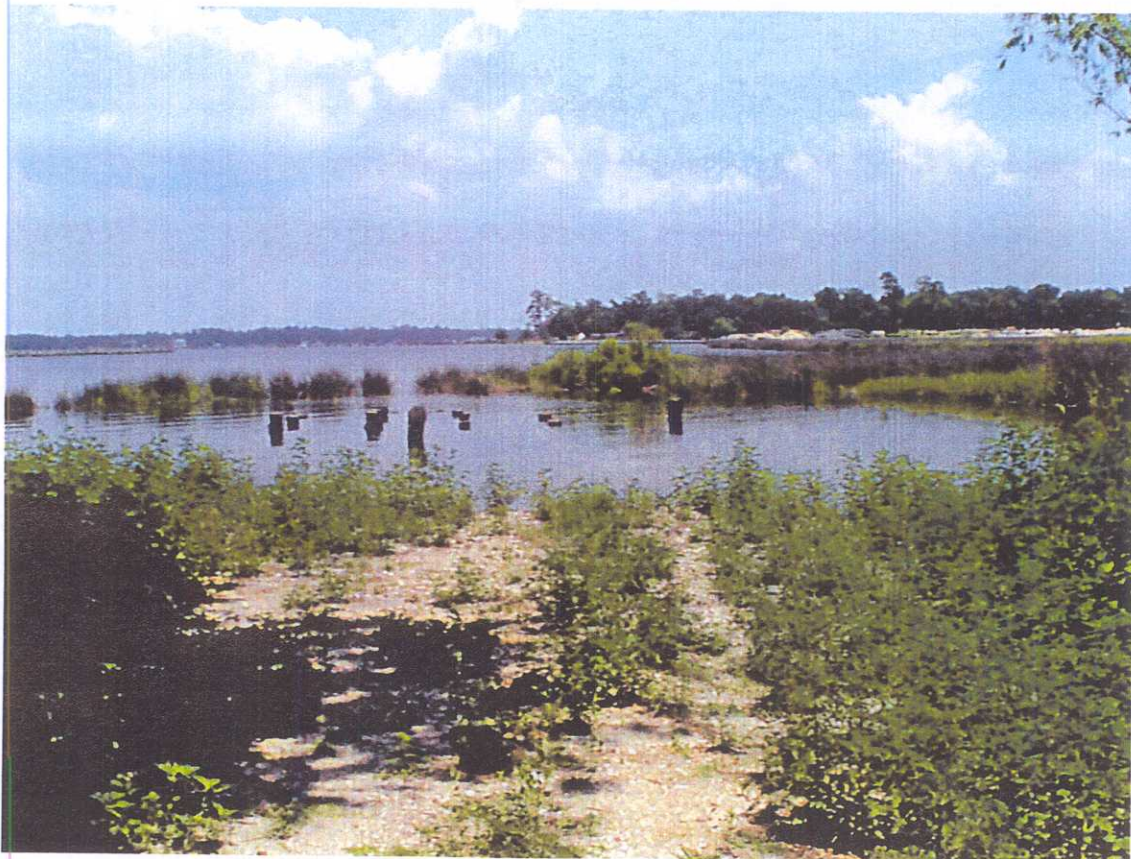
Mitigation area prior to revegetation at high tide looking toward the Back Bay

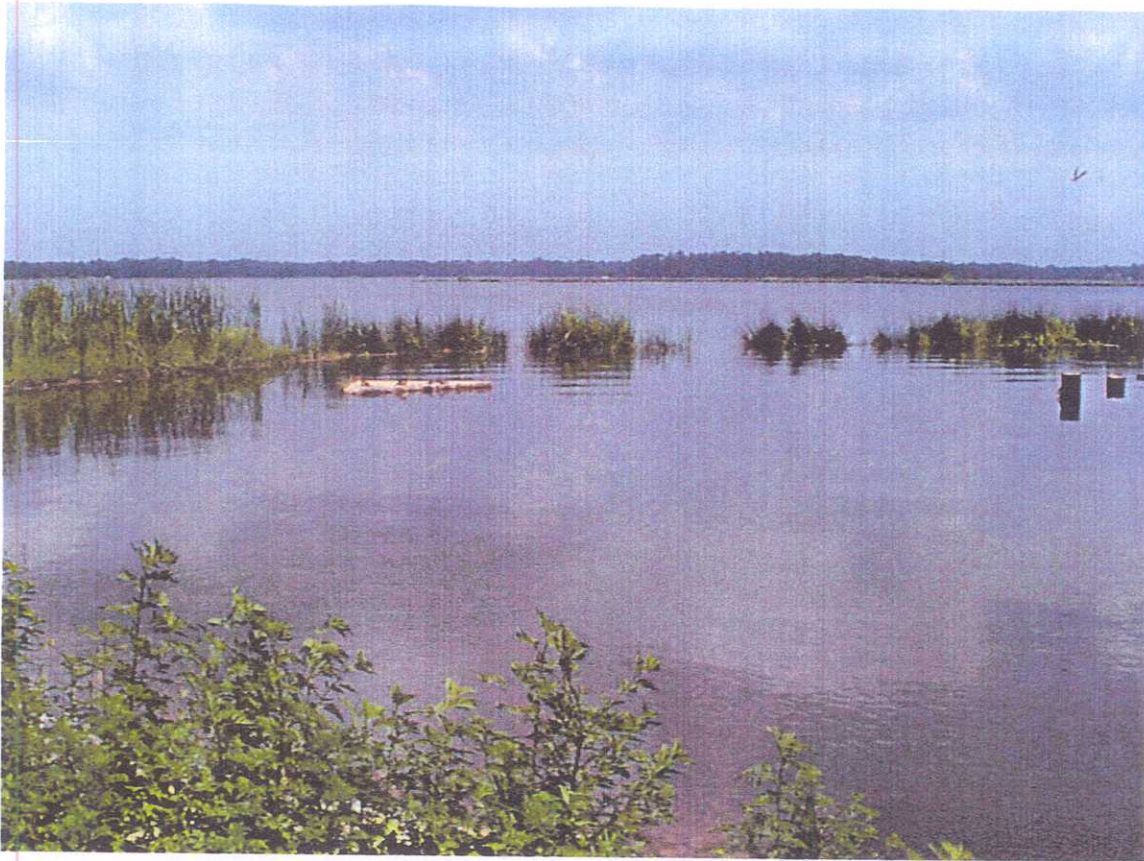
Concrete slab and pilings in the mitigation area at high tide looking toward the Back Bay

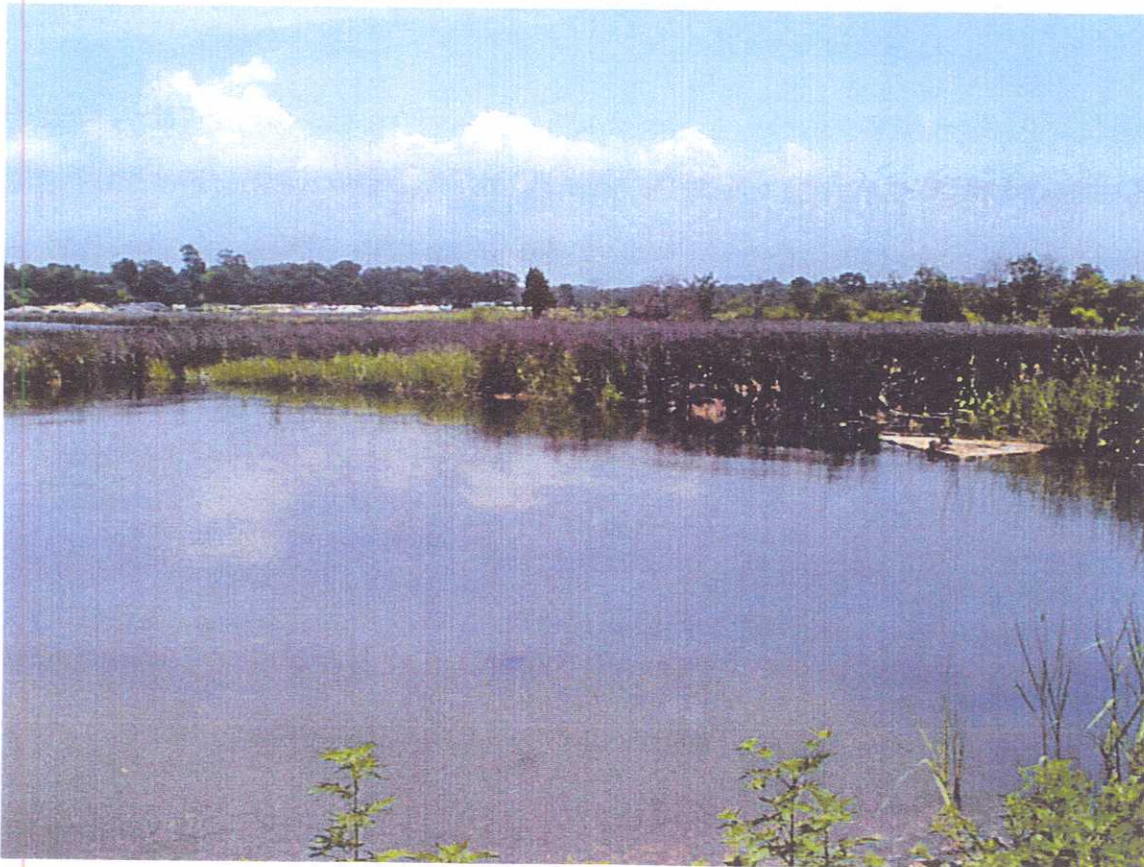
Concrete slab in the mitigation area prior to revegetation at high tide looking east

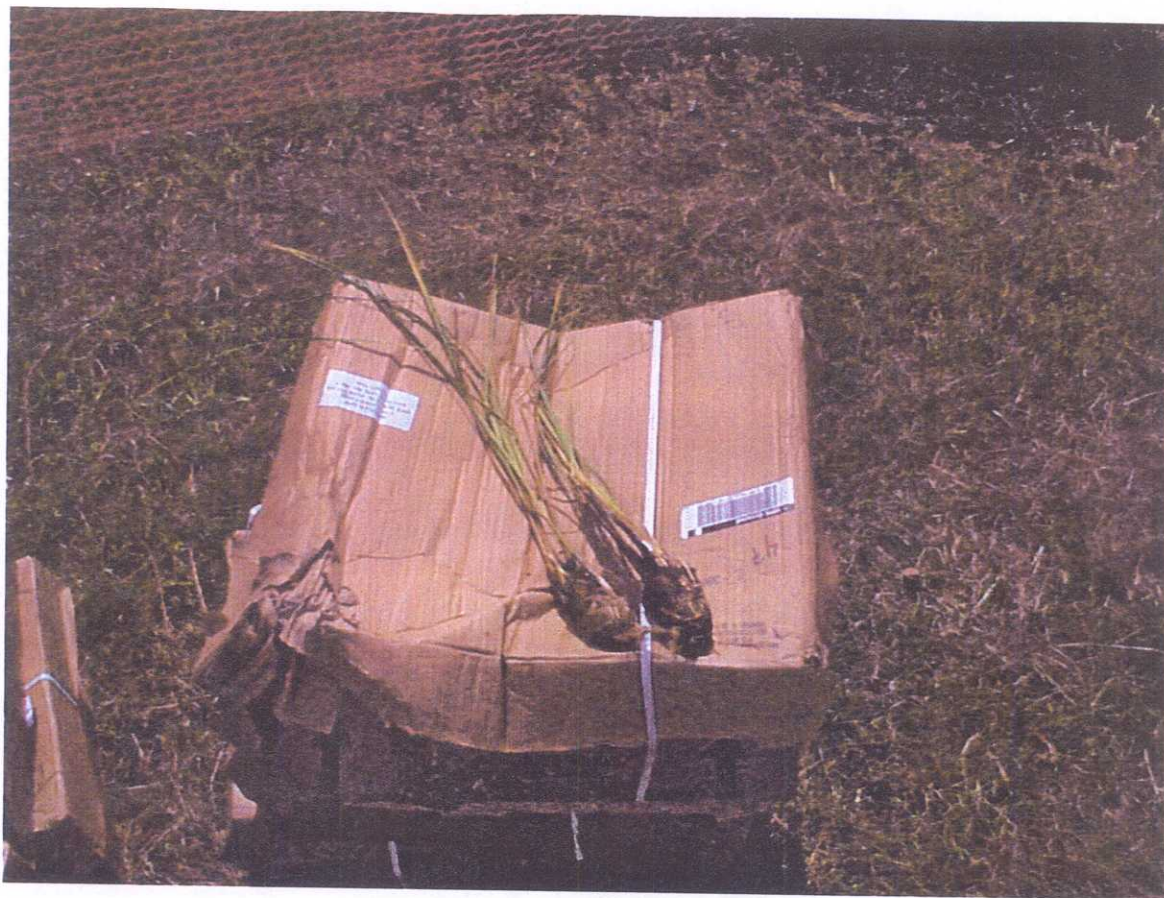
Horticultural Systems plants

The project specifications and the wetland delineation report both confirmed the native plants that were to be used to revegetate the mitigation area. IT also consulted the Gulf Coast Research Laboratory for types of native plants and numbers of plants per square foot to arrive at the quantity of plants necessary to revegetate the mitigation area estimated at slightly less than twenty two thousand (22,000) square feet. Fifteen thousand (15,000) Black Needle Rush (*Juncus roemerianus*) and five thousand (5,000) Smooth Cord Grass (*Spartina alterniflora*) plants in two inch liners were ordered from Horticultural Systems Inc of Parrish Florida on January 13, 1999. Delivery of the plants to the site was delayed until September of 1999 due to a delay in the design because of differing site conditions and the demobilization of the LF3 project. IT received five thousand (5,000) Smooth Cord Grass plants and five thousand (5,000) Black Needle Rush plants on September 10, 1999. Instructions from Horticultural Systems on how to plant the plants were requested. IT was told to create a hole with a post hole digger or other implement to allow the root ball of the plants to be buried and covered. September 11, 1999 IT completed planting the first ten thousand plants. September 20, 1999 IT received ten thousand Black Needle Rush plants and continued planting. Concrete was encountered below the mud line so an adjustment in the plant spacing was made to avoid the concrete. September 21, 1999 IT continued planting the Black Needle Rush plants. September 22, 1999 IT completed planting the Black Needle Rush plants, removed empty boxes and debris from the area and demobilized from the site.

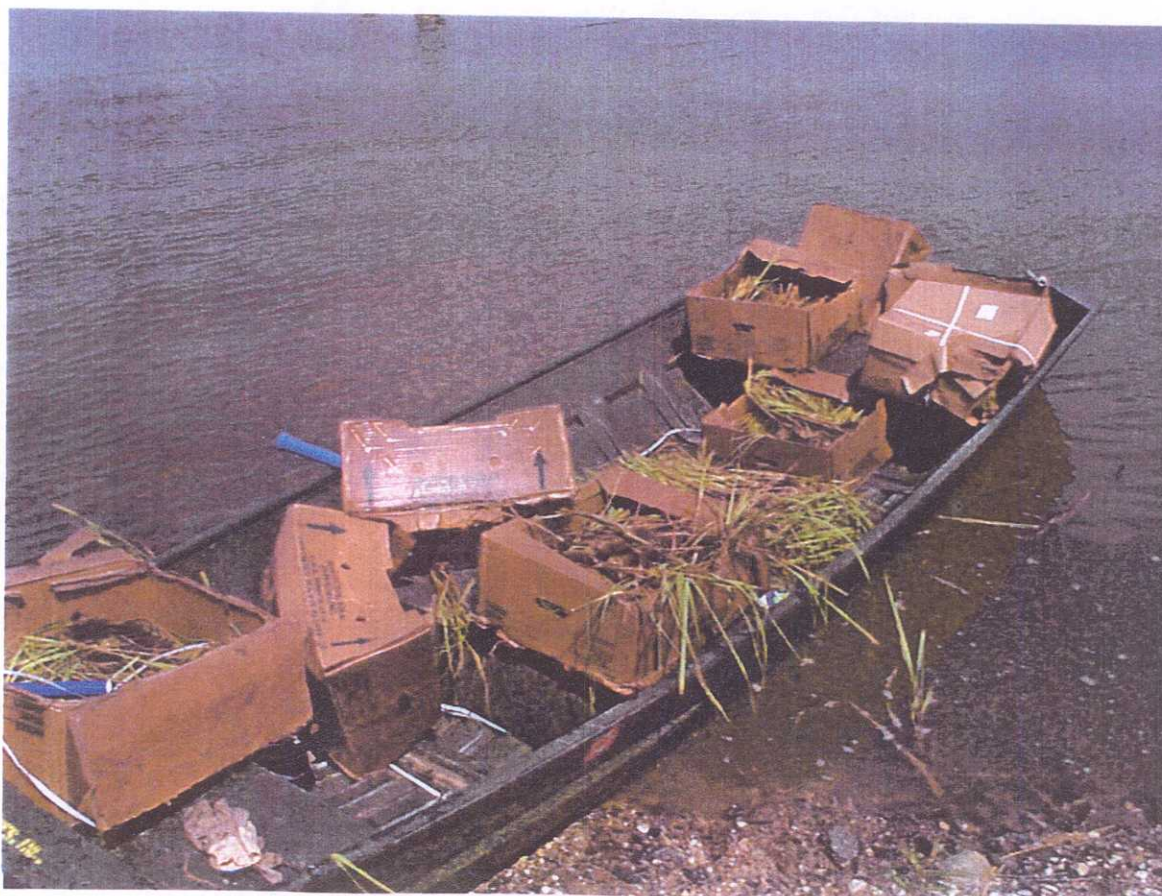
Boat with plants in the mitigation area

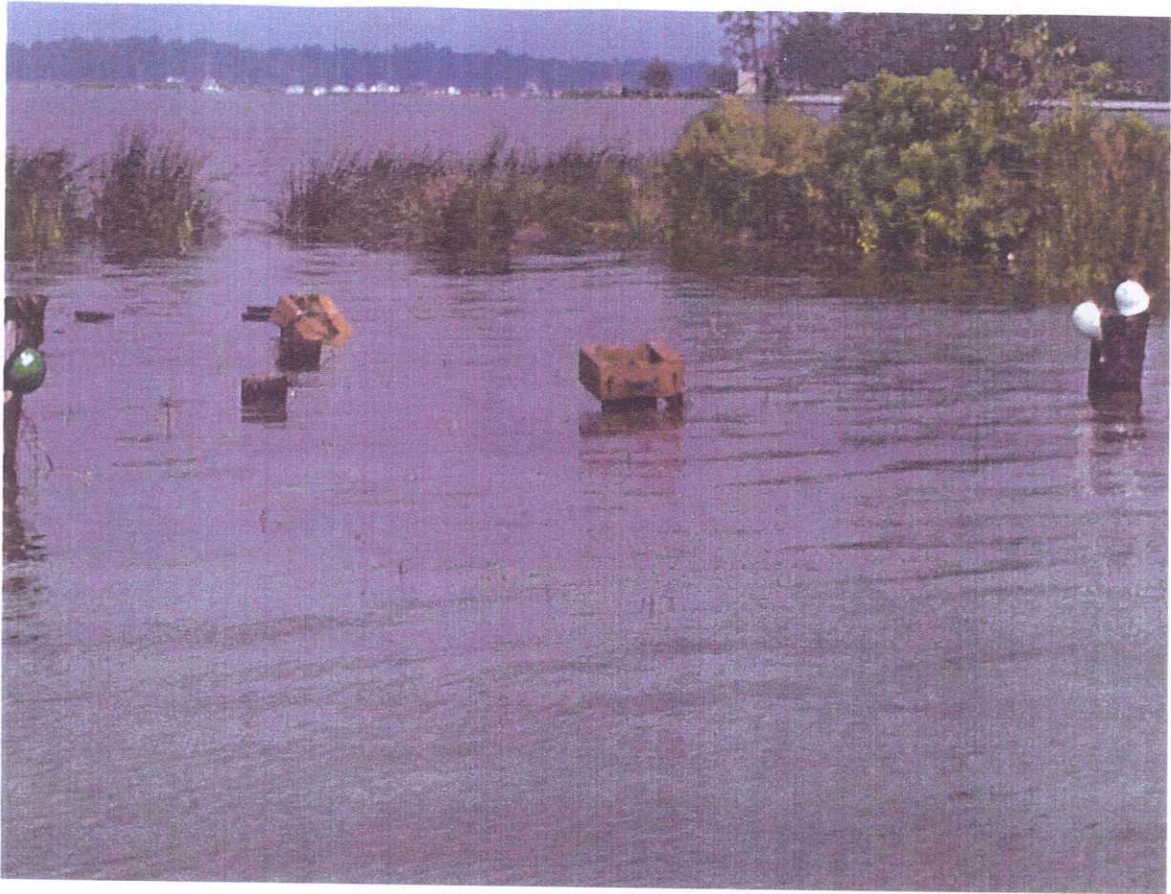
Replanting the mitigation area

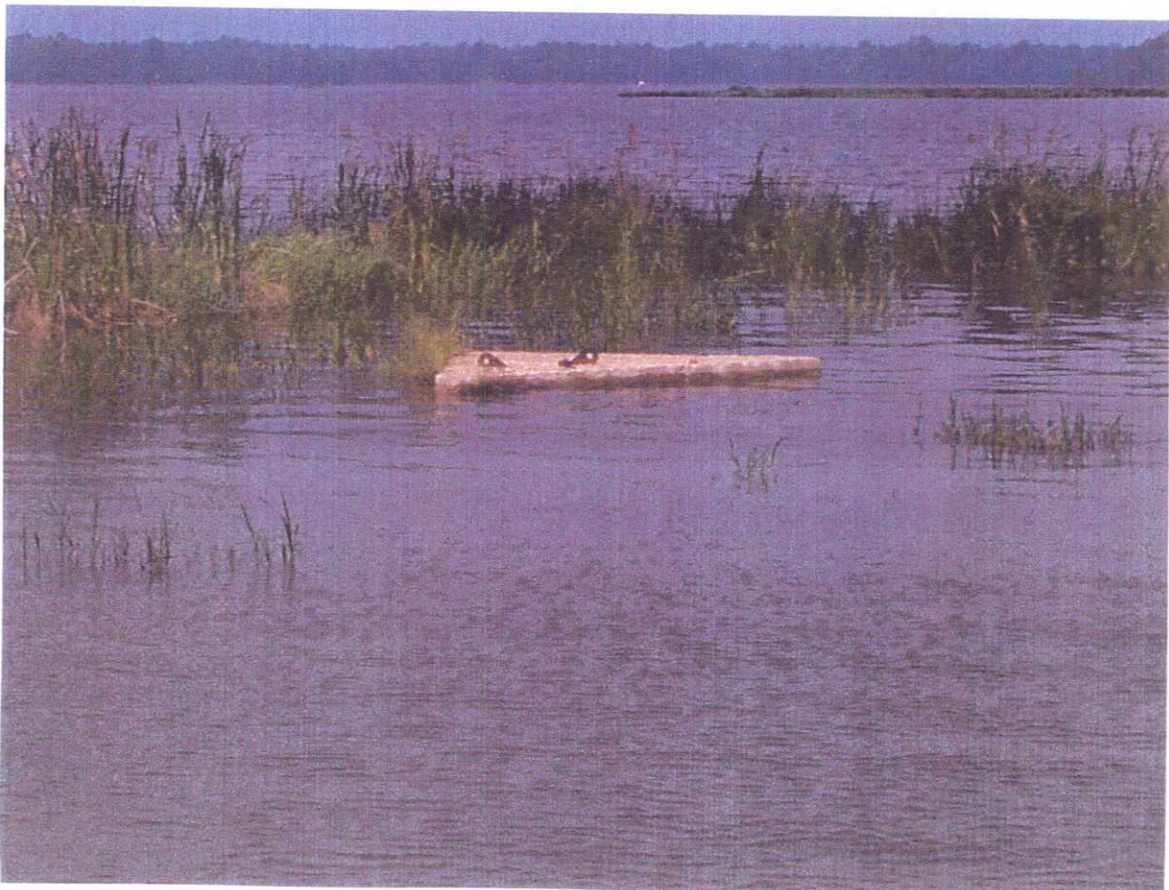
Revegetating the mitigation area

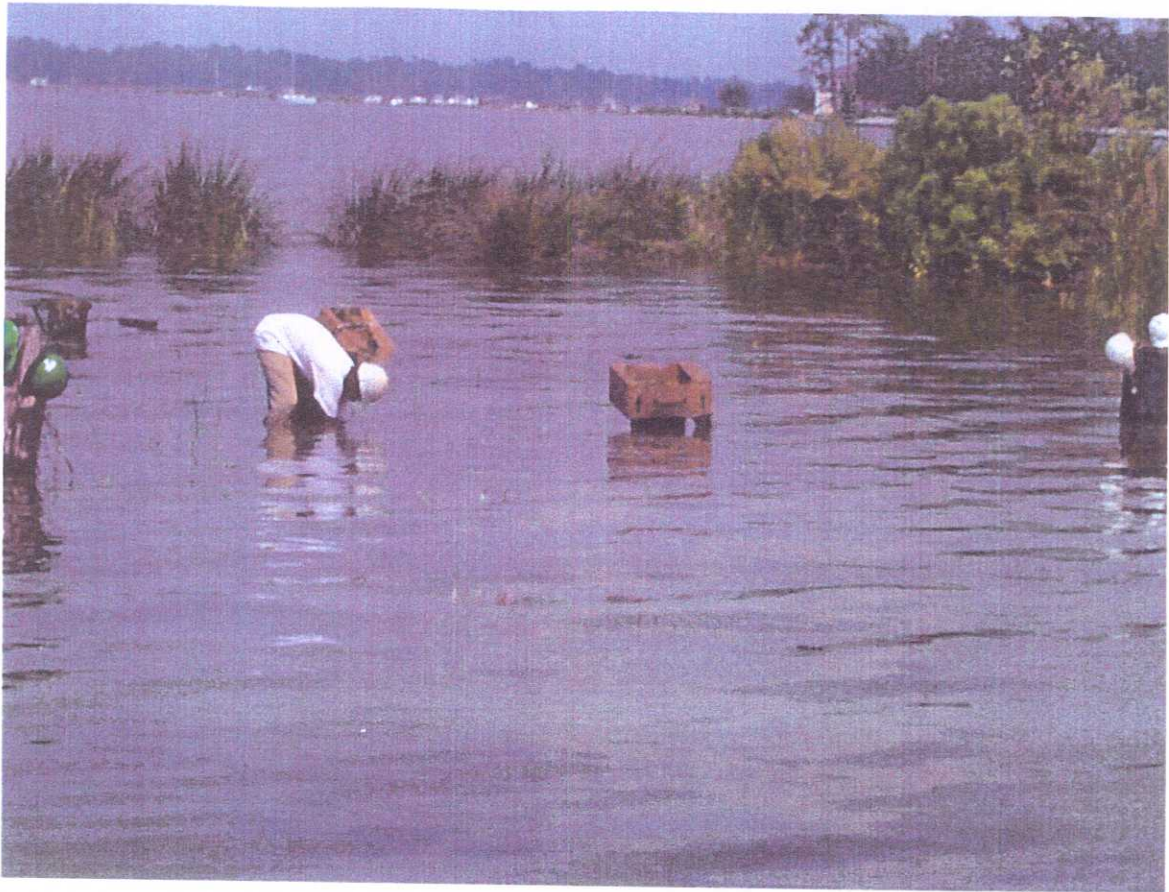
Replanting the mitigation area

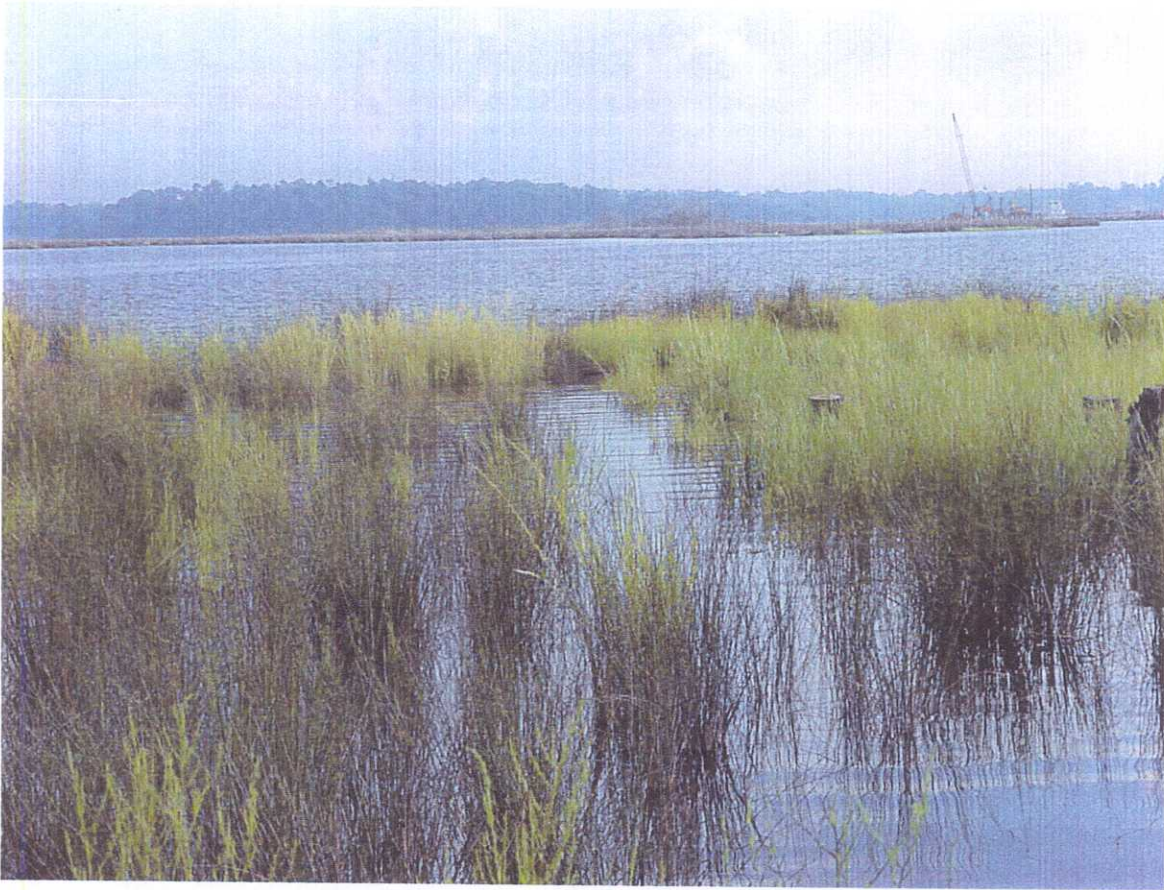
IT Project Manager, David Tester; AFCEE Team Chief, Rodney Arnold; Keesler AFB Remediation Project Manager, Lisa Noble and AFCEE Botanist, Mary Anderson met at the archery range mitigation area on September 12, 2000 for the purpose of performing the annual evaluation of the site to determine the success of the mitigation effort. Areas of the mitigation area were observed to be bare of any plants. These areas appeared to be too deep to support the Black Needle Rush and Smooth Cord Grass plants and it was determined that the plants originally introduced to these areas had probably floated away. The plants that had survived in the mitigation area appeared to be large and healthy. The group determined that it would be necessary to rework some of the deeper areas where plants were missing by creating mounds and move some of the plants from the adjacent wetlands into those areas.

Annual evaluation far end of mitigation area west side

The following summarizes the action items agreed to by the group to rework the mitigation area to make in successful:

- Excavated the berm separating an area identified as Site A to the right of the road approaching the mitigation area and use the material to create mounds in the low areas of the mitigation area and allow the tide to bring water into Site A.

- Remove cattails from Site A and save them for replanting.
- Excavate silty clay loam from Site A and use this material to cover the material excavated from the berm to create mounds. It was estimated that three (3) inches of the material from the berm should be covered with three (3) inches of the silty clay loam from Site A to create the mounds in the mitigation area.

- Collect *Juncus* from adjacent wetlands and split the plants into five (5) to seven (7) stems.
- Replant the *Juncus* in the new mounds and in the Site A area at a depth of eight (8) to ten (10) inches at high tide.

- Replant cattails around the edge of Site A.
- Schedule the completion of the rework for October.

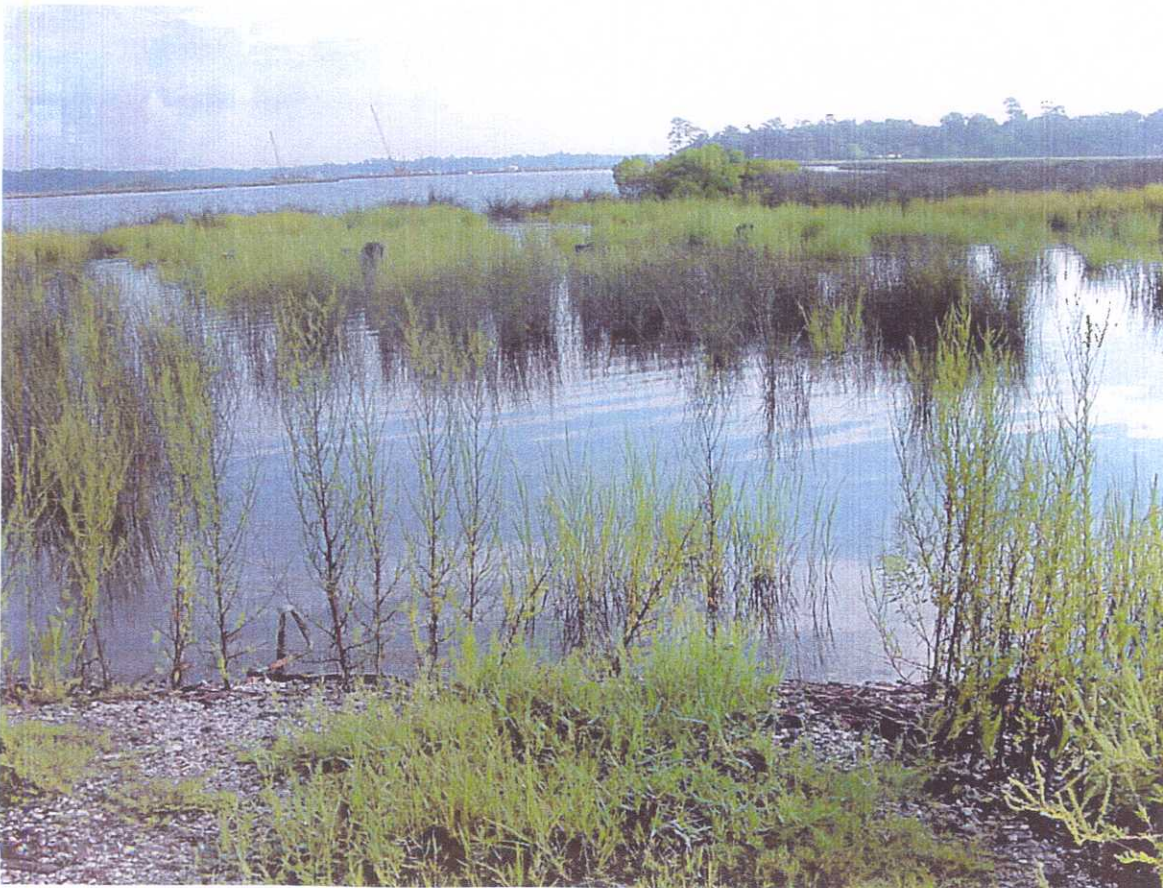
Annual evaluation mitigation area looking toward the Back Bay

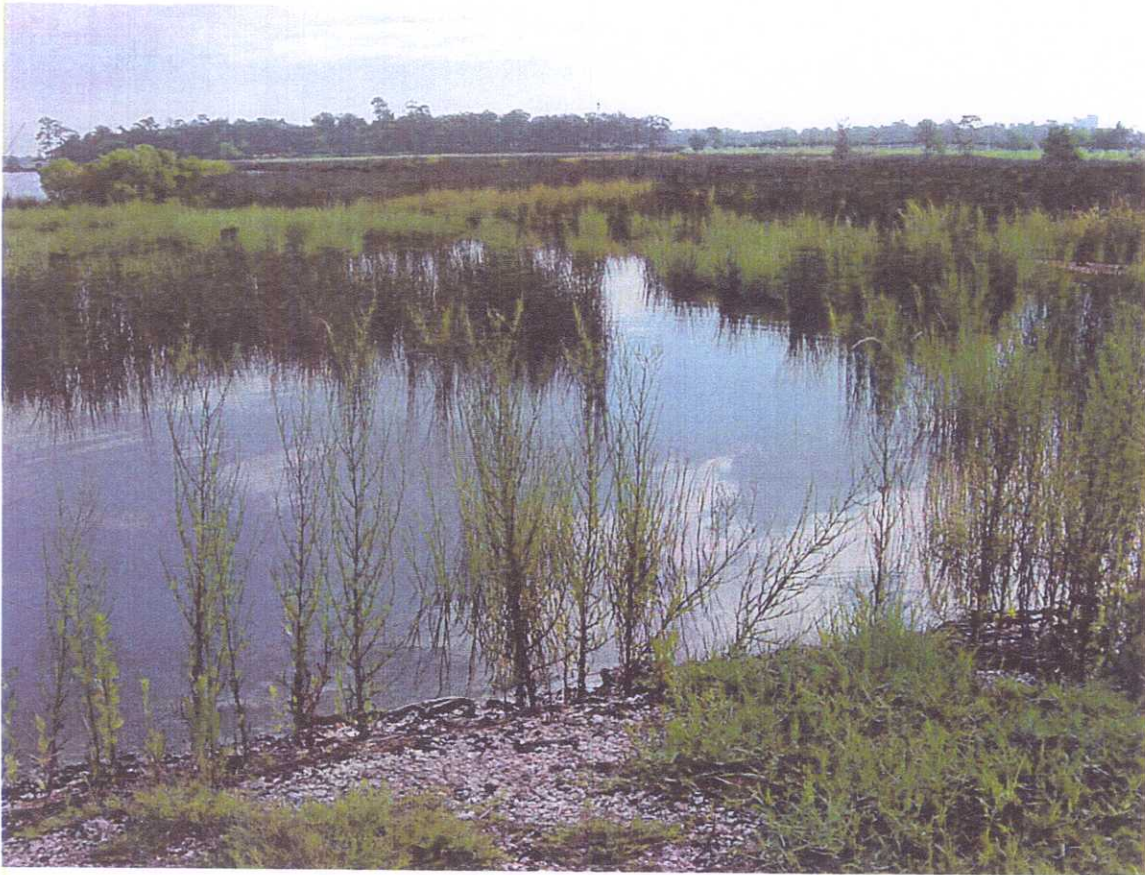
Annual evaluation mitigation area east side

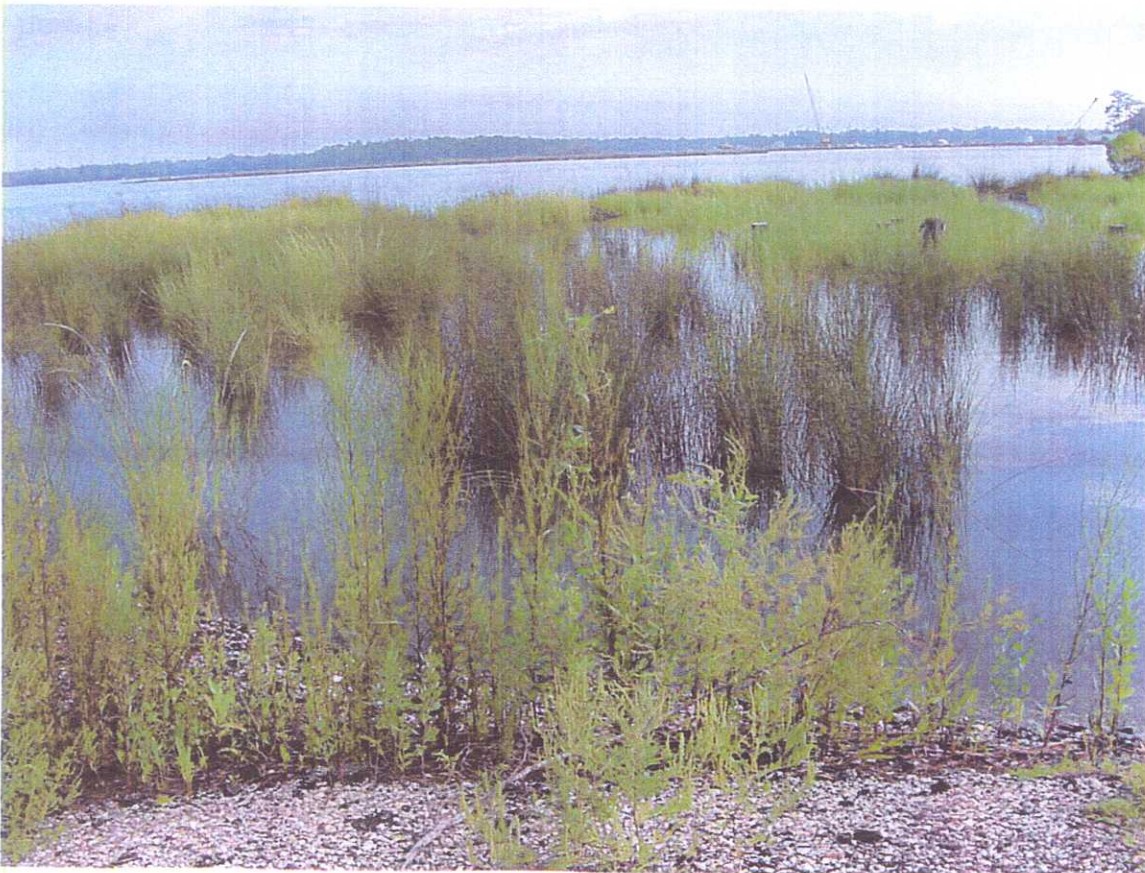
Annual evaluation mitigation area west side

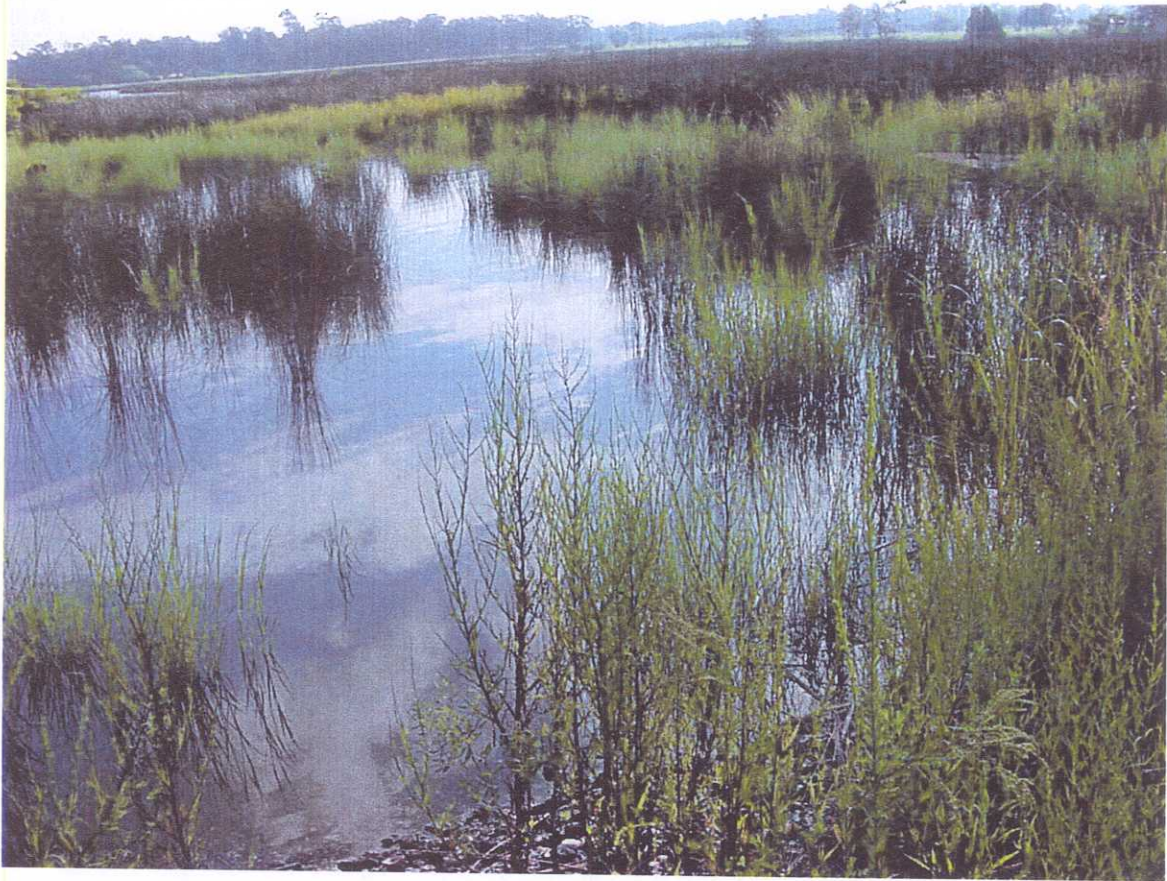
Annual evaluation east side of the mitigation area

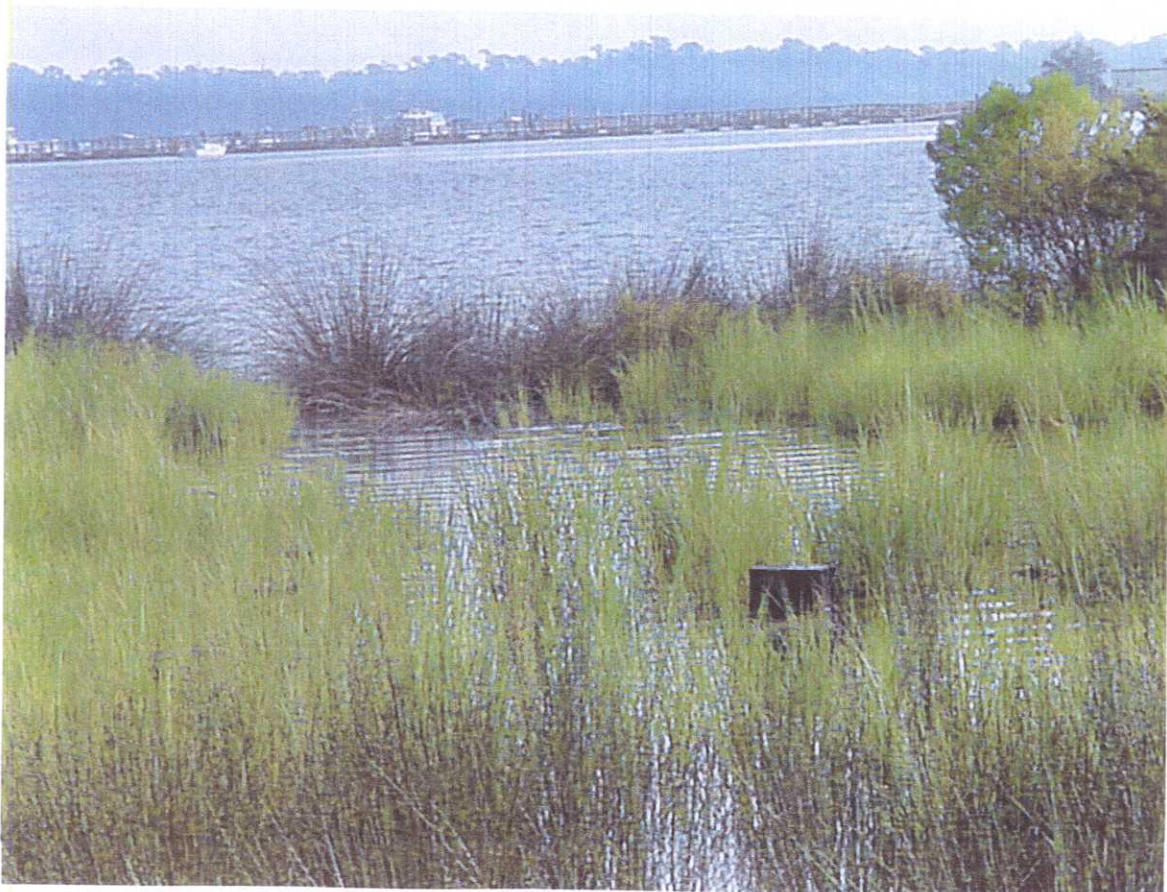
Annual evaluation far end of mitigation area

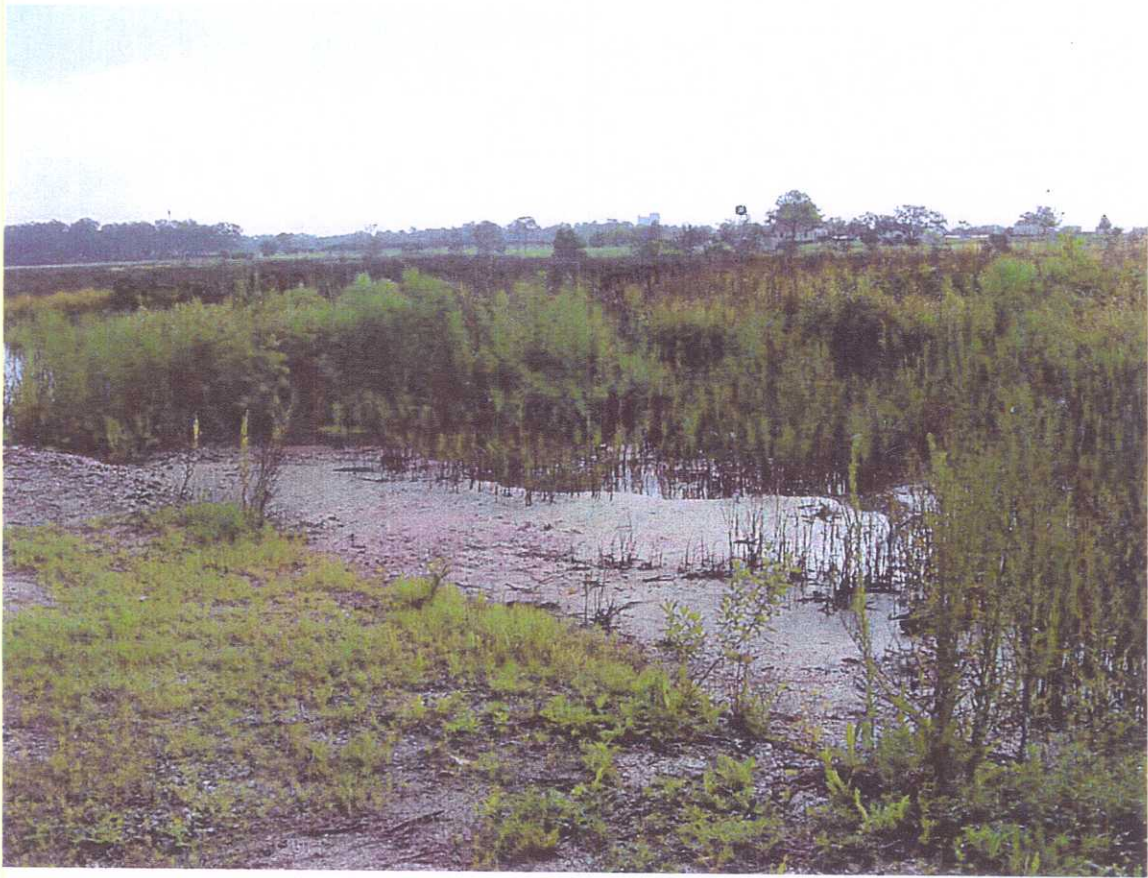
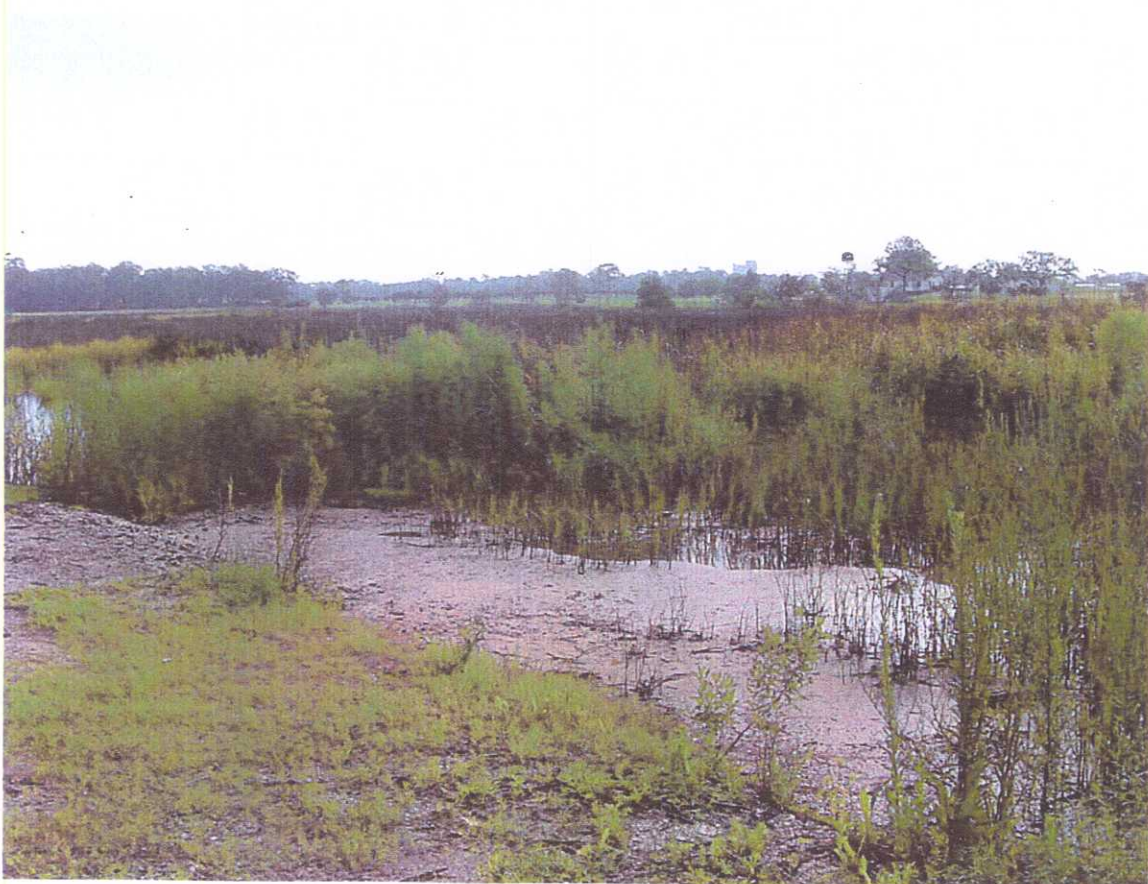
Annual evaluation Site A

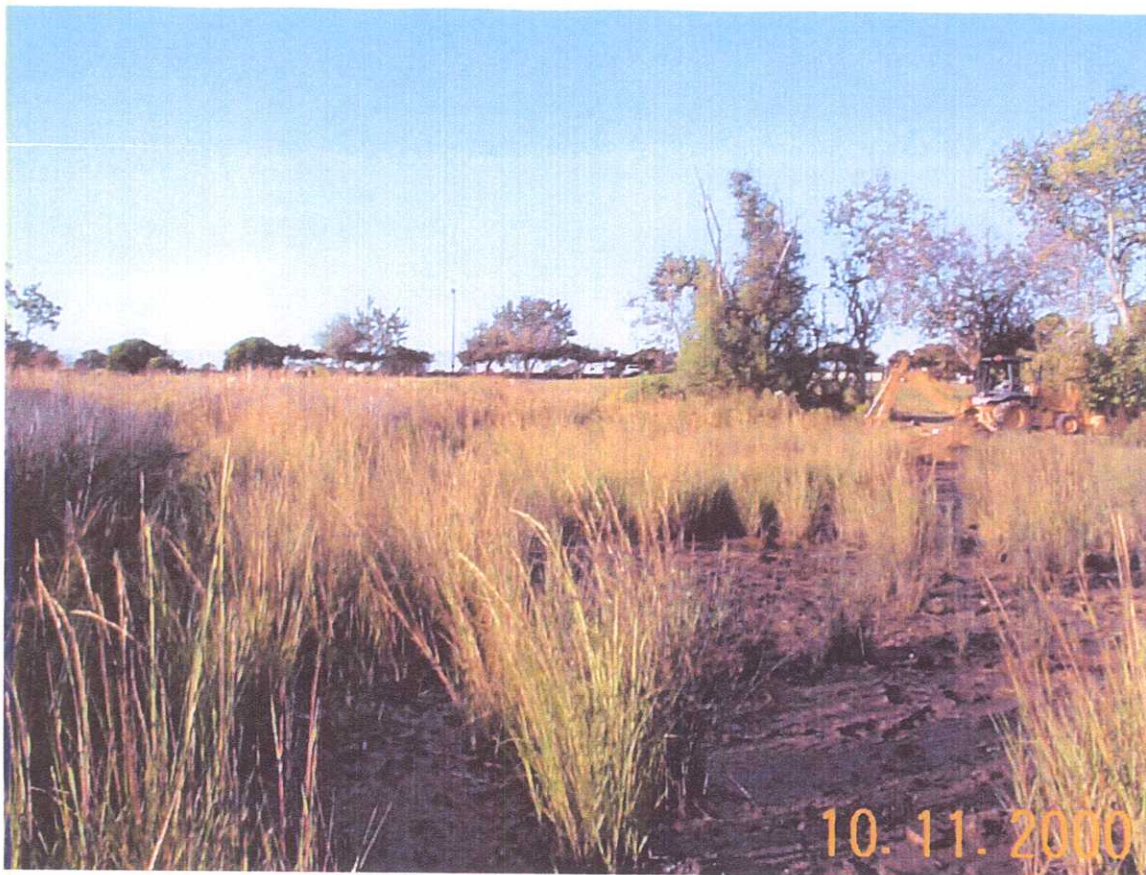
Rework of the mitigation area with material from Site A

Mary Anderson and IT Field Superintendent, Norman Honea with his crew meet on October 10, 2000 to complete the rework of the mitigation area. October 11, 2000 IT removed the cattails in an area designated as Site A adjacent to and east of the road to the mitigation area. Site A was excavated and the material was used to build mounds in the low areas at the end of the road to the mitigation area where the water level at high tide was above that necessary to support the plants. IT graded the excavated area of Site A and replanted fifty (50) stems of *Typha* (cattail) and eighteen (18) clumps (180 stems) of Black Needle Rush plants. IT created Sixty six (66) mounds and planted an average of two clumps of Black Needle Rush plants per mound for an additional one hundred and thirty two (132) plants (1320 stems) in the areas that were low. Another 115 plants (approximately 1150 stems) were scattered throughout the mitigation area. Because the tide was low IT was able to create hummocks in the deeper

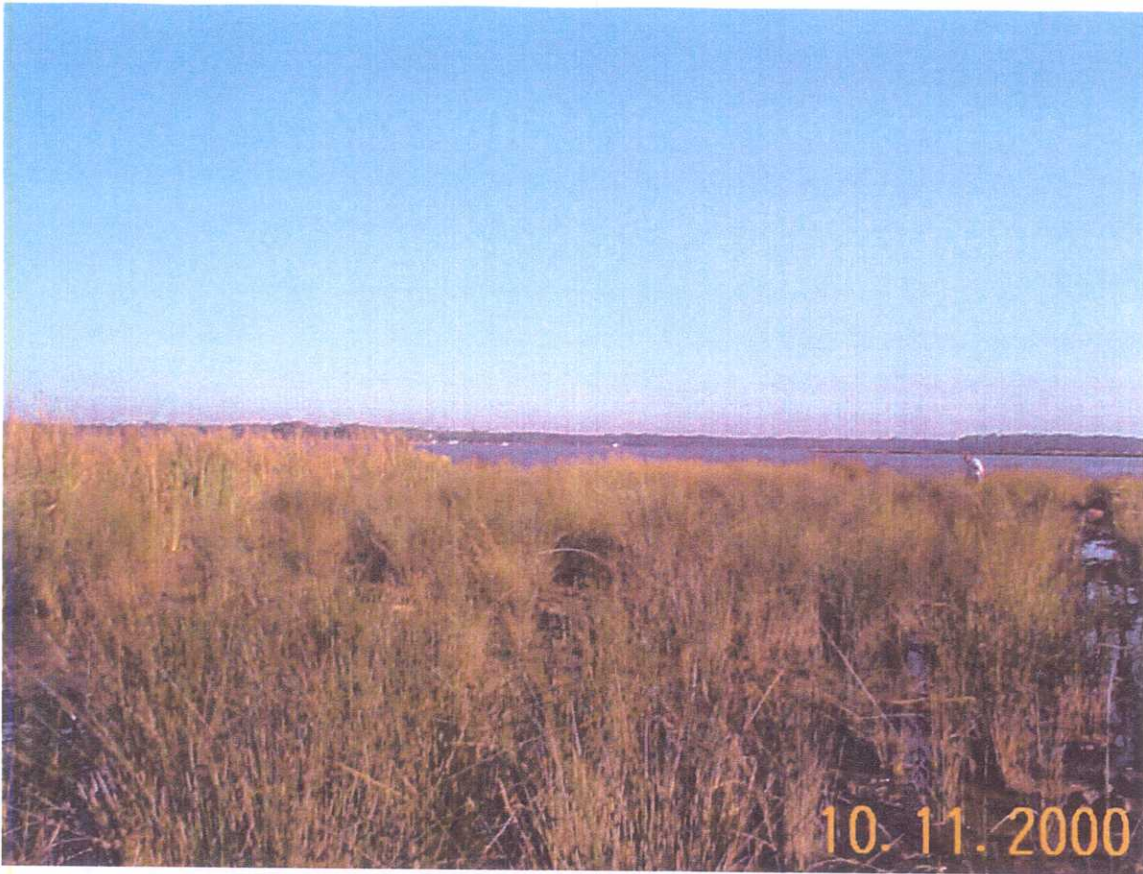
Rework of the mitigation area new plants

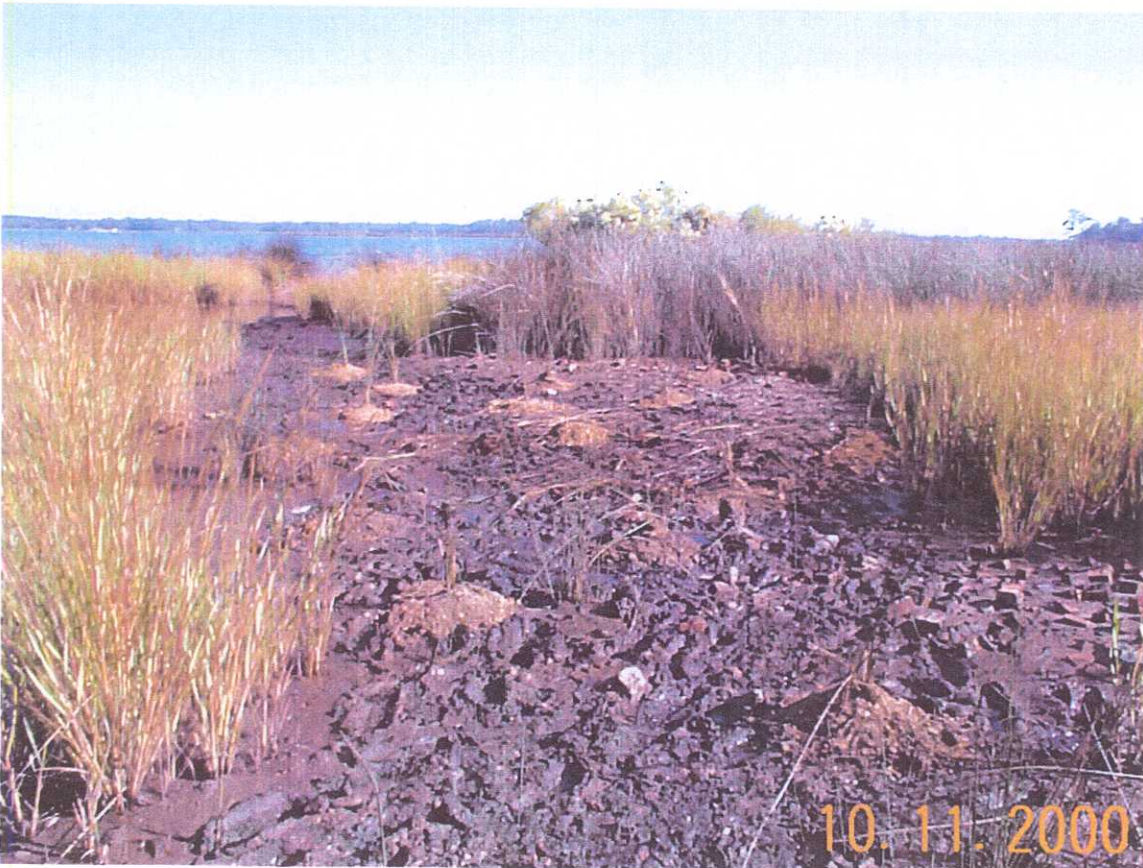
Rework of the mitigation area new mounds and plants

open water areas out past the pilings by carrying pails of sandy soil to the open areas and dumping it to form mounds. These areas were also planted with Black Needle Rush. The donor plants were removed from the marsh area directly adjacent to the mitigation area to the east side of the site.
